NAVAL POSTGRADUATE SCHOOL

COMBAT DAMAGE ASSESSMENT TEAM
A-10/GAU-8 LOW ANGLE FIRINGS
VERSUS
SIMULATED SOVIET TANK COMPANY (ARRAY 18)
(AEROJET LOT NUMBER AJD79A181-001)
(30 AUGUST 1979)

R.H.S. STOLFI
R.R. McEACHIN

MAY 1980

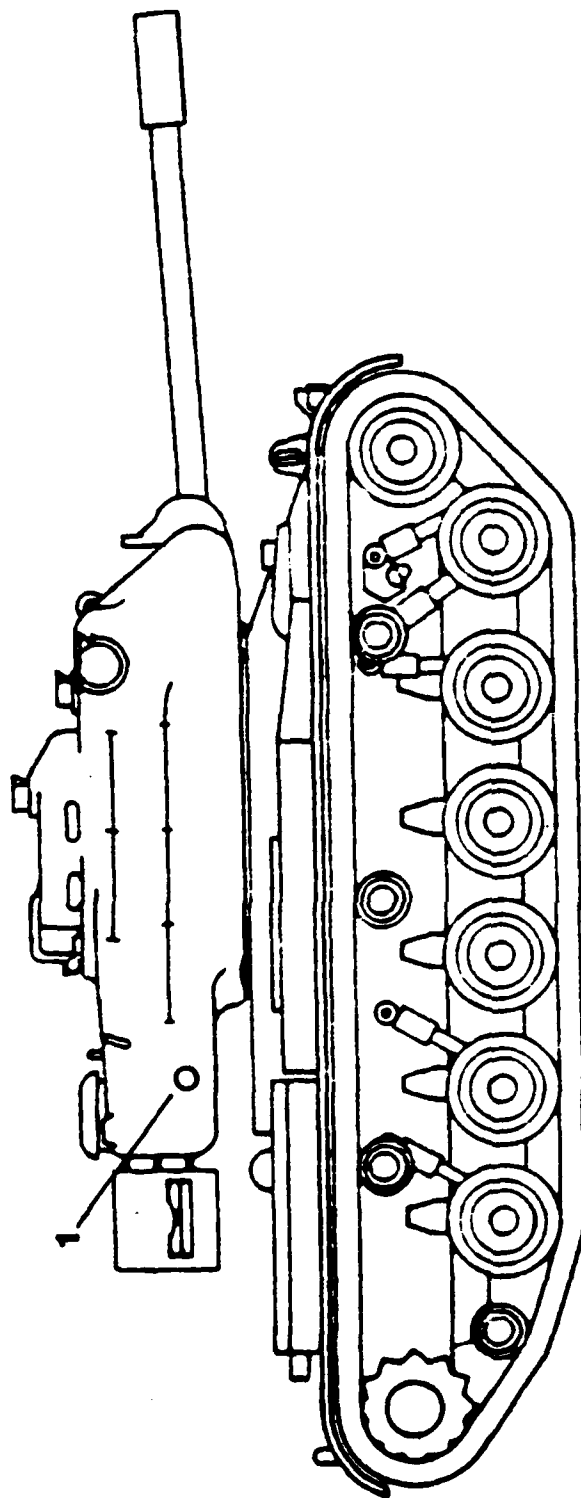
The single impact on tank 34 partially penetrated the right side of the turret (Figure 15) with no behind-the-plate effects.

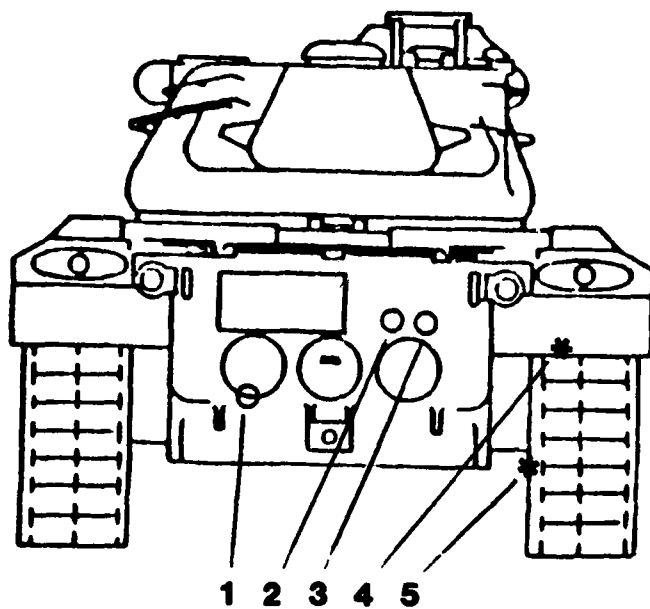
None of the impacts on tank 29 (Figure 16) contributed to the assessment of either an M- or an F-Kill.

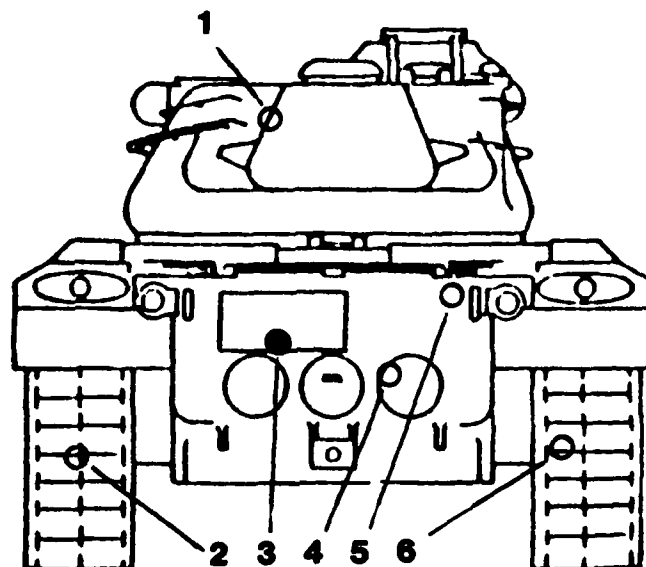
All of the impacts on the target were ricochets off the ground. Impact 3 (Figure 17) perforated the rear hull armor but did not possess enough residual energy to penetrate into the transmission case. The remaining five projectiles impacted the track and suspension system, hull, and turret with no harmful effects on mobility or firepower.

Note: Perforation resulted from ricochet off ground

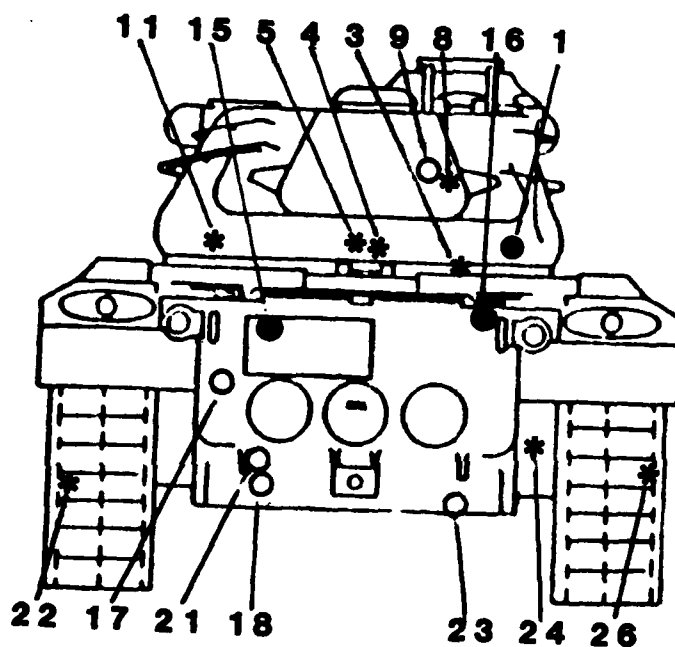
FIGURE 20. Tank 4, Impact Diagram.

100% M-Kill and 100% F-Kill resulting from the following observed effects (Figures 18, 19, and 20):

- a. M-Kill: The assessment of a 100% M-Kill is based on impacts 15 and 16 (Figure 21) which perforated the rear hull armor and penetrated into the engine compartment, severing two oil cooler lines and penetrating the transmission case; and on cumulative damage to the track and suspension system caused by impacts 19, 25, 28, 30, 31, and 32. Crew casualties caused by impact 1 contributed to the kill.
- b. F-Kill: The assessment of a 100% F-Kill is based on impact 3 which hit in the turret ring and jammed the turret so that it would not traverse, and on impact 1 (Figure 22) which perforated the turret and caused casualties to the commander, gunner, and loader.

NOTE: Hits 19 and 20 impacted on the inside of the left compensating idler wheel and the left track respectively.
